MECHANISMS AND REMEDIATION
OF CUT BATTER FAILURES ALONG THE QUEENS ROAD AT
WAINIGASAU AND NAMUKA I LAU, VITI LEVU, FIJI
ISLANDS.

A THESIS SUBMITTED IN PARTIAL FULFILMENT OF THE REQUIREMENTS FOR

MASTER OF SCIENCE IN ENGINEERING GEOLOGY

UNIVERSITY OF CANTERBURY

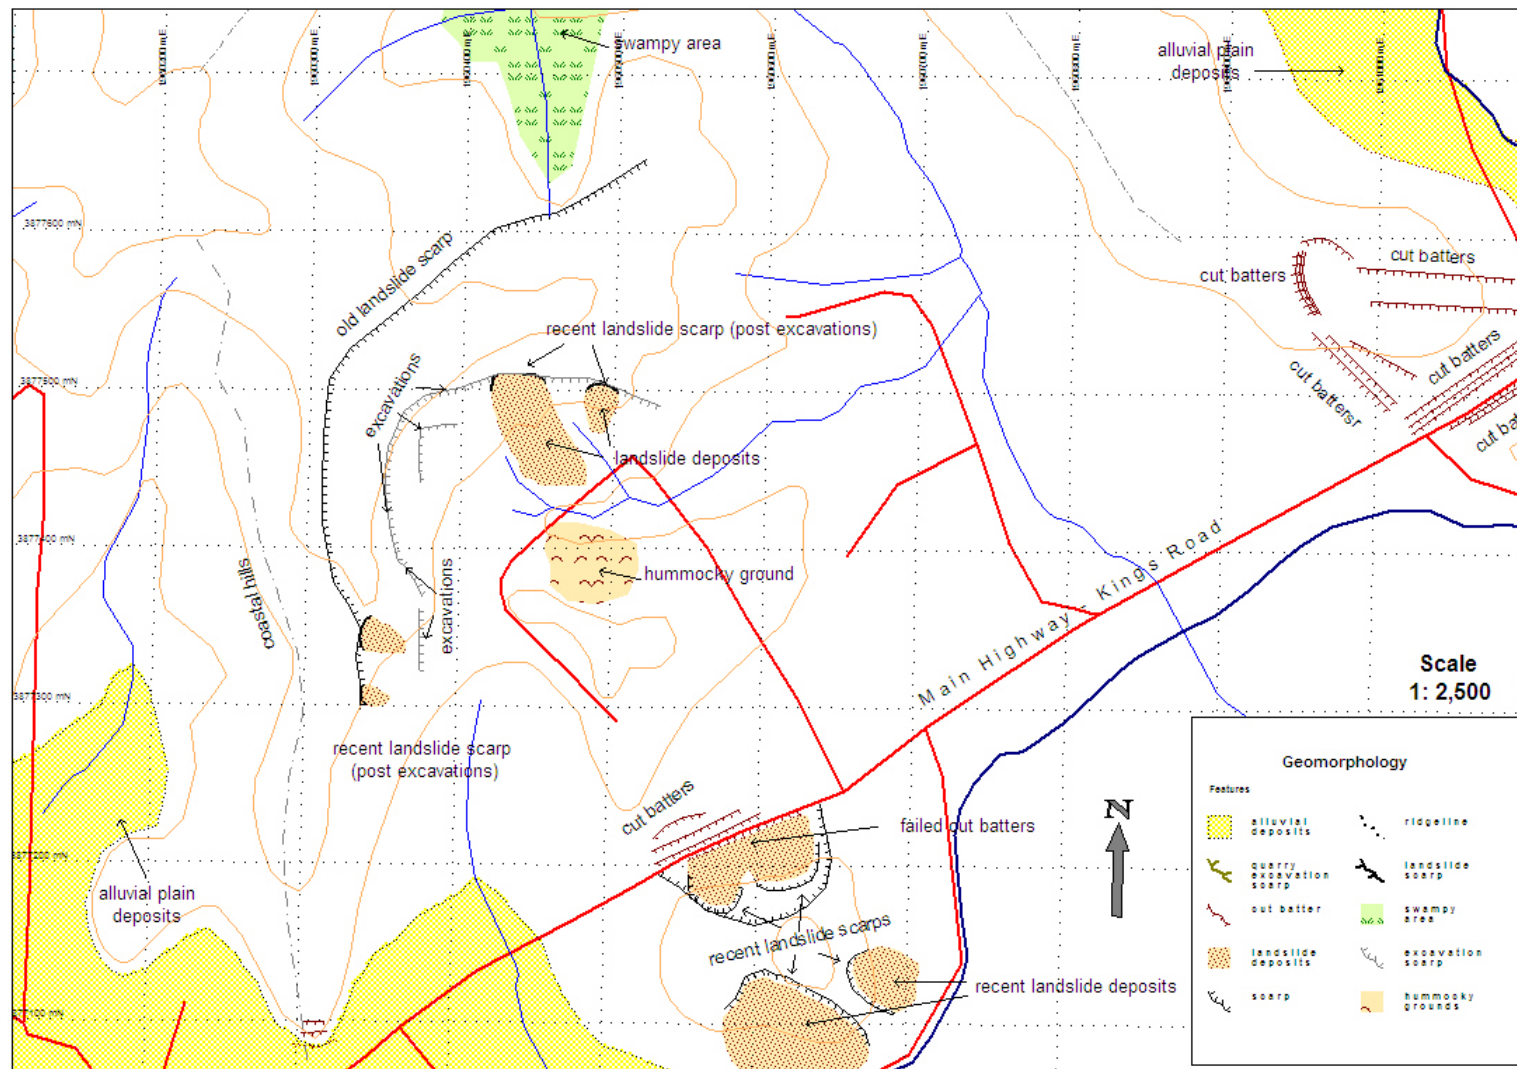
Figure 3.4 Geomorphological map of the Namuka i lau area

The coastal hills form a northern and western border to the Namuka i lau site (Figure 3.6). An older landslide scarp could have been reactivated during the construction of the cut batters at Namuka i lau and subsequent failure scarps and recent landslide scarps and deposits can be seen 300 metres north of the cut batter slopes at Namuka i lau. A small area of undeveloped hummocky ground are also visible signs left of the past events as much of the past slide deposits have been developed over as a residential subdivision. Smaller debris slides are also visible north of the Namuka i lau area occurring in the confines of steep creek incised valleys. The cut batter on the southern side of the main highway (Queens Road) has failed during a prolonged intense rainfall period in 2002. The cut batter was constructed on the northern face of a topographic knob with an elevation of 45 metres. The southern side of the knob also has two debris slide events which are occurred between 1986 and 2002 (post aerial photography of 1986 and older then event of 2002).

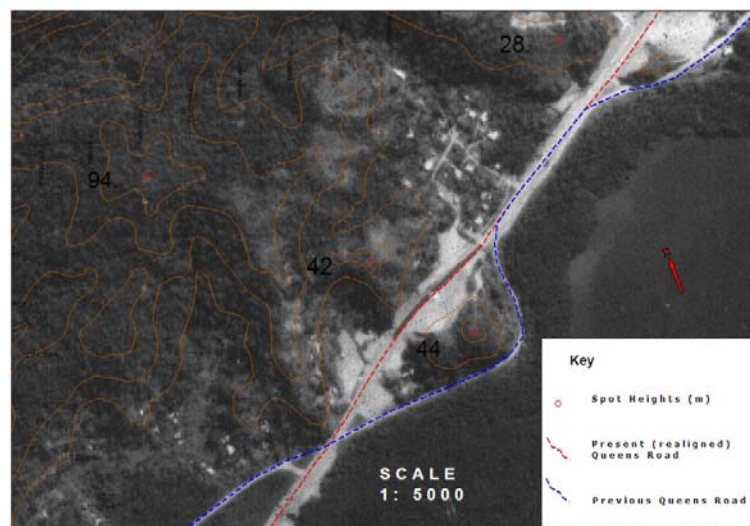
Figure 3.5 Realignment of the Queens Road

The Namuka i lau site is made up of cut batters on either side of the Queens Road. The cut batters were formed through a hill (~42 metres height at summit) during construction of the current Queens Road. As seen in Figure 3.5 the previous Queens Road meandered around the small hill which was largely removed during the construction of the current Queens Road resulting in cut batter construction on either side of the current Queens Road. At initial construction cut batters on both the northern and southern sides of the road had 3 benches originally cut at around 50-60 degrees. The dimensions of the benches at Namuka i lau are summarised in the Table 3.1.

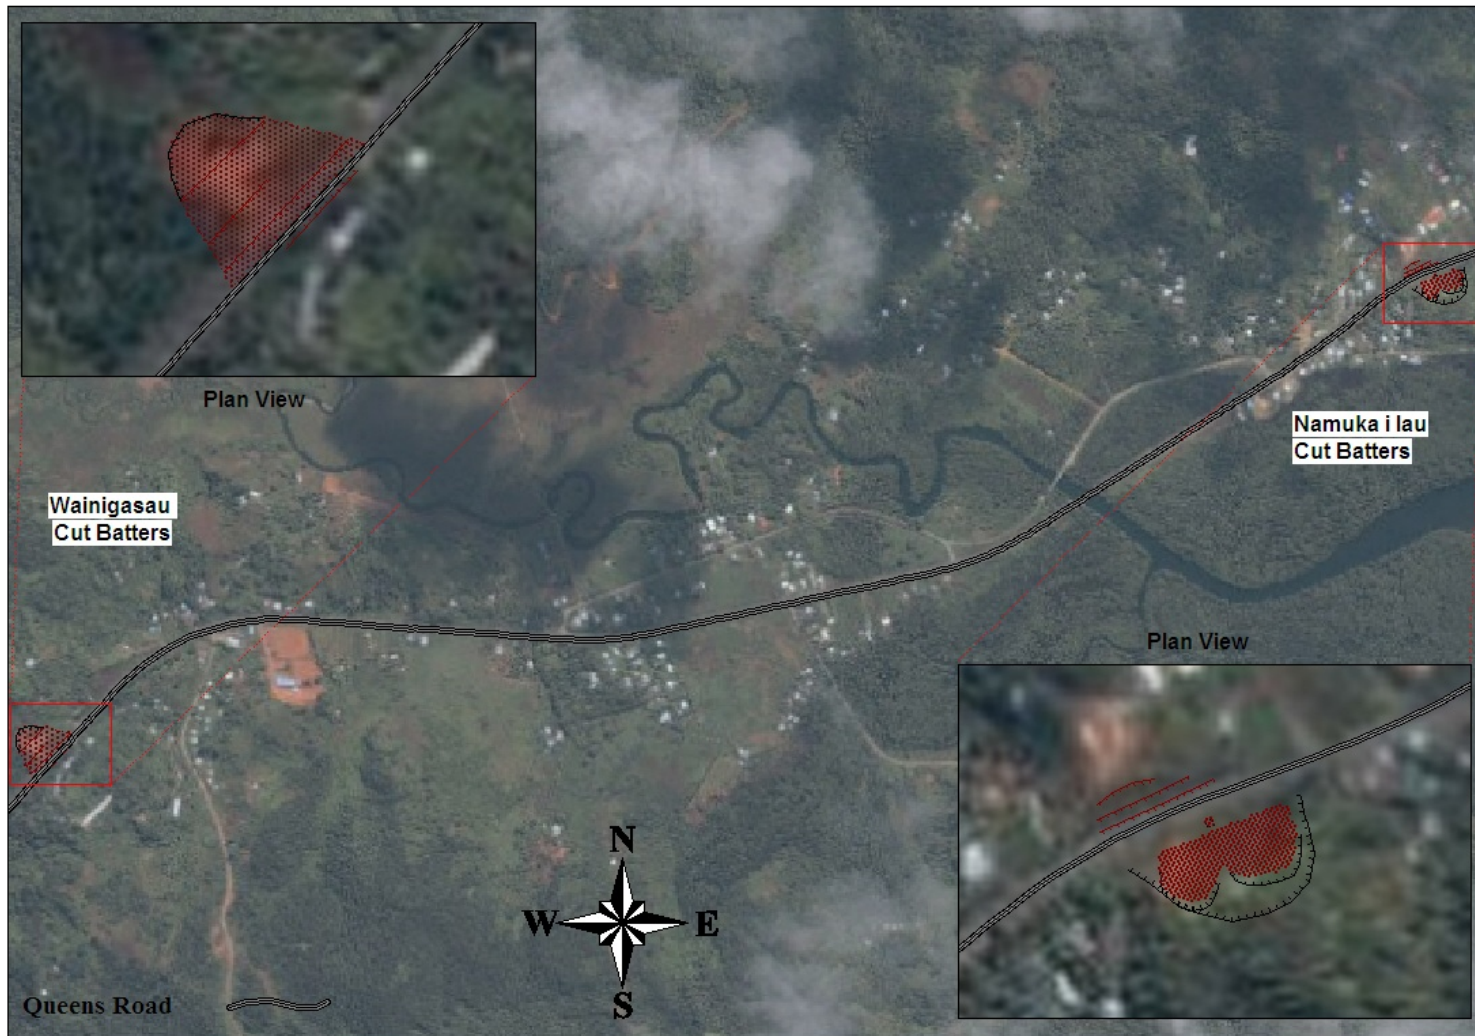
Figure 3.6 Plan view of cut batters at Wainigasau and Namuka i lau.

The cut batters are aligned northeast/southwest, with the northern cut batters sloping southeast and the southern cut batters sloping northwest (see Figure 3.6).

Subdivision development has occurred above the cut batters post construction with housing construction being carried out post 1998 (last aerial photography). This has provided additional loading to the cut batters (see Figure 3.6).

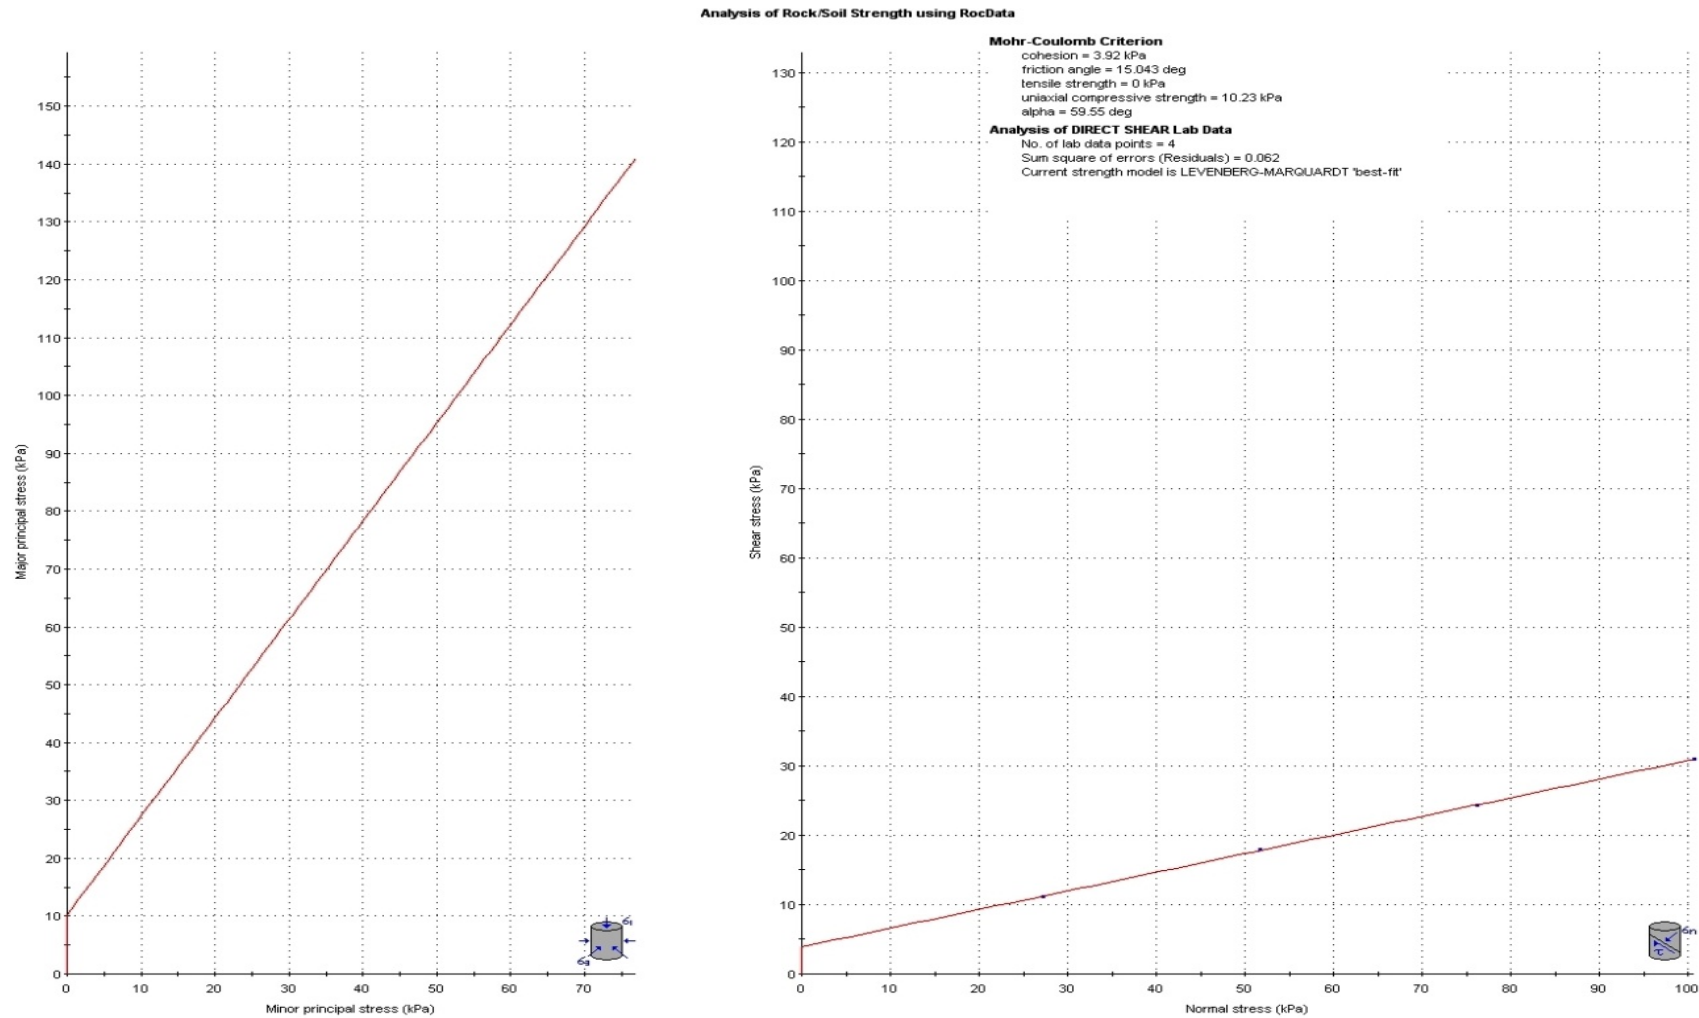
Figure 4.4 Mohr-coulomb diagrams for ring-shear tests carried out on Veisari Sandstone matrix material

diagrams (see Figure 4.4) show a friction angle, ϕ_r , of 15.043 degrees and cohesion, c_r , of 3.92 kPa. Typical values for soil and rock properties from Hoek and Bray (1981) show the friction angle value of 15.043 as determined for the tested sample lies within the range of soft cohesive clays. The cohesion of 3.92 kPa as determined through the shear testing is low, comparably even lower than that of soft bentonite clays.

However, the above tests result may not represent in-situ conditions as coarse materials have been removed from the sample prior to ring-shear test. The tested sample therefore does not represent the true geological anisotropy and heterogeneity of the material tested, possibly influencing the outcome of the results. It is apparent that the tested conglomerate matrix has a very low cohesion value and a low internal friction angle, making it vulnerable to failure. Also, the high moisture content in the clay minerals is responsible for the reduction in effective stress and strength. Propagation of the failure surface through the polymict conglomerate occurs readily as the polymict conglomerate has been totally weathered to silt and clay fractions.
